PBP89360 Replacement Parts

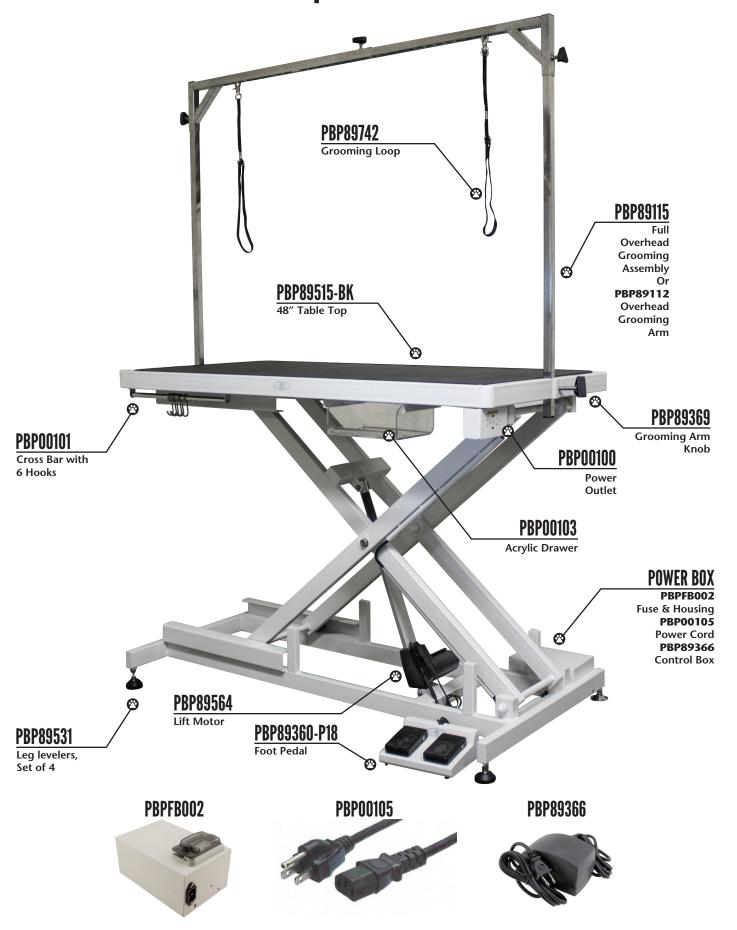
Main difference between a "Rocker Switch" and "Schneider Box".

The "Schneider Box" will have a switch with a clear plastic window over it.
