PBP89326 Replacement Parts

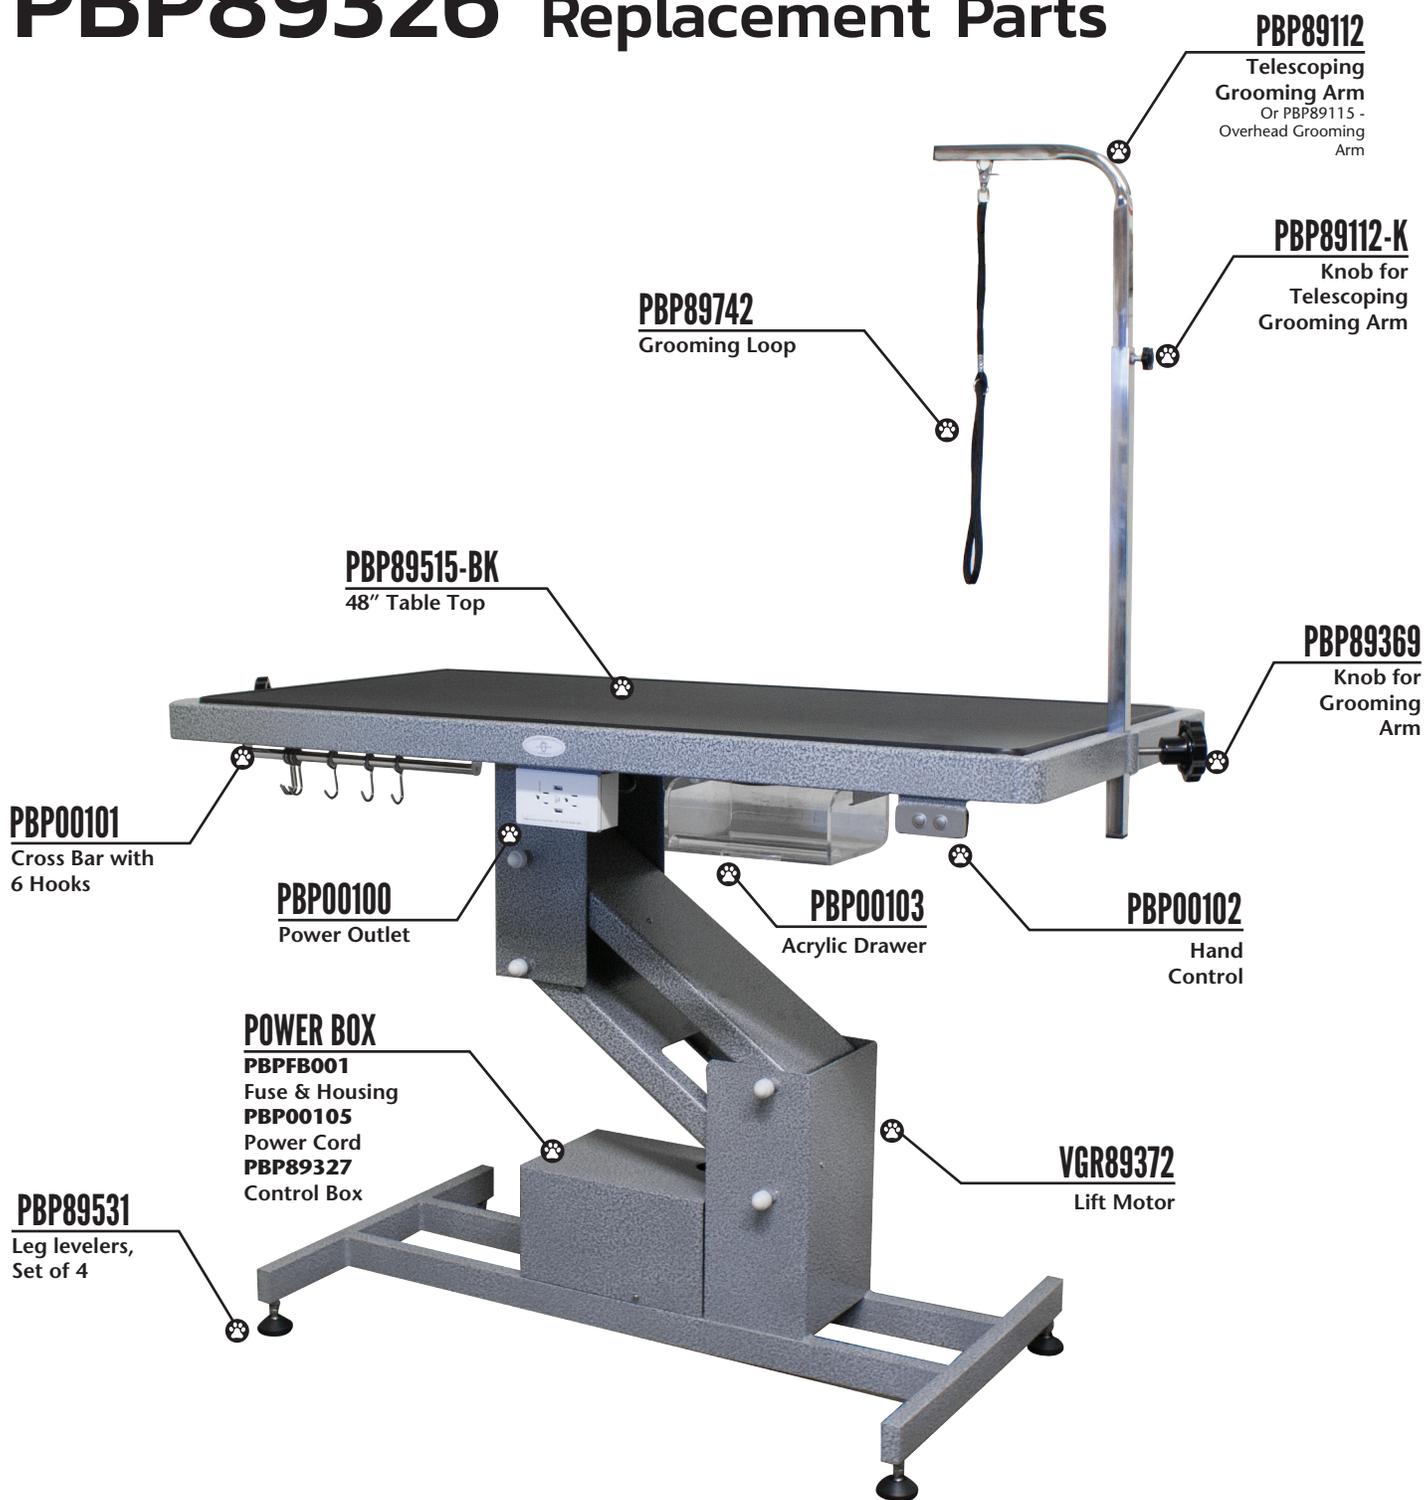
PBPF001

PBP00105

PBP89327

- Have customer check power cord with a known good cord. Usually a TV or a Desktop computer will use the same power cord. If it works with a known good cord send **(Power Cord) PBP00105**. (If no known good cord, see next step)
- If table still does not work send **(Control Box) PBP89327** and **(Power Cord) PBP00105**
- If table still does not work send **(Hand Switch) PBP00102**
- If tables still does not work send **(Motor) PBP89372**
- If table still does not work send **(Schneider Box/ Fuse and Housing) PBPFB001**
